NEWTOK HEALTH CLINIC

Alaska Rural Primary Care Facility Assessment and Inventory Survey

Final
July 23, 2001

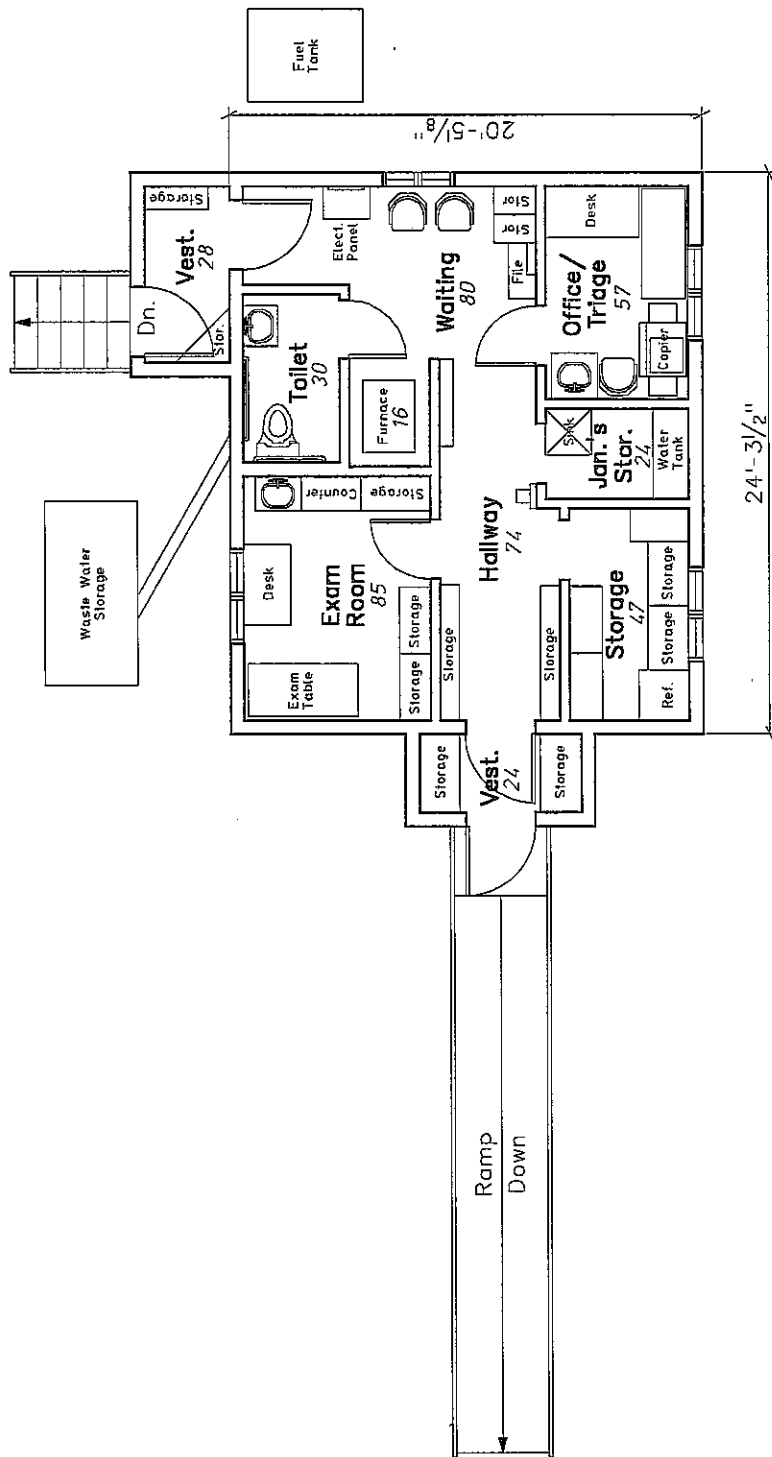
Existing Newtok Clinic Floor Plan

566 Sf.

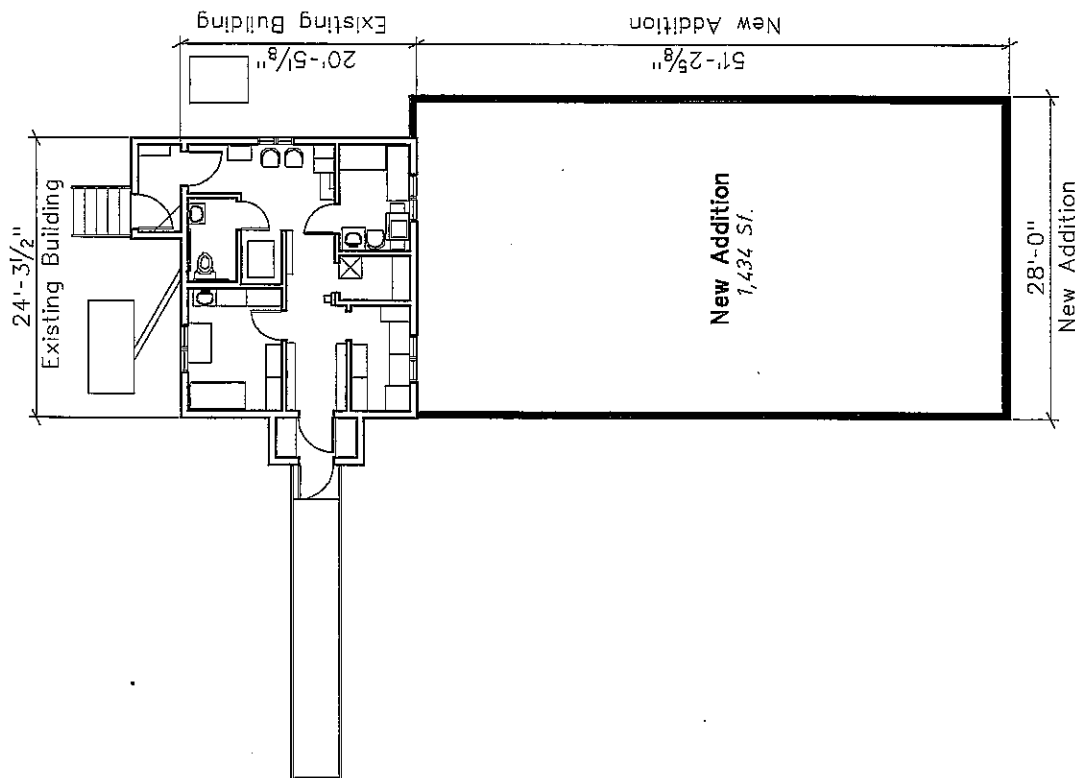
New Addition Newtok Clinic Floor Plan

566 Sf. + 1,434 Sf. = 2,000 Sf.
